Masyatul Husna Othman, Md Azree Othuman Mydin

### **Condition and Defect Surveys on Penang Heritage Centre: A Case Study on Georgetown World Heritage Building**

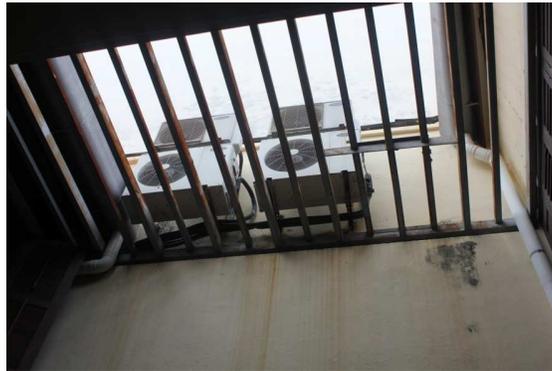
No evidence of any significant defects was found. There is also no leakage on pipes. The Legal Adviser will be able to check if the surface water and foul sewer are together channelled or the systems are separate. Figure 1 shows the drainage and rainwater pipes on the inspected building. It should be pointed out that the drainage and rainwater pipes were in good condition. Regular maintenance was done in order to make sure the drainage and rainwater pipes for this building works well.

**Figure 1.** The drainage and rainwater pipes was in good condition from accessible inspection

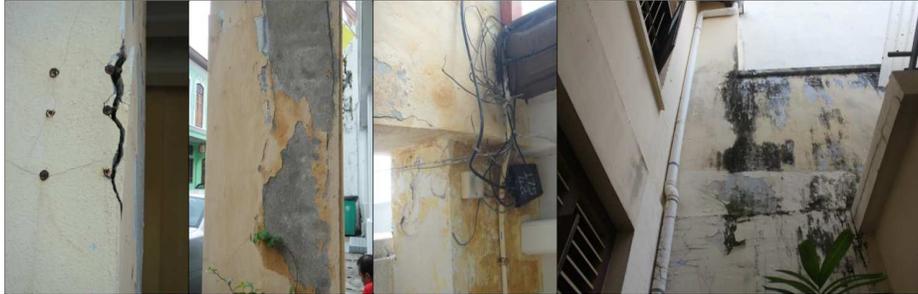
Figure 2 visualizes the condition of external walls and elevation of the building. It can be clearly seen that there are some of minor defects on the external walls. There are peeling paintings and crack on left column of walls. There also had a stain coating on upper of the walls.

**Figure 2.** From left: the paint layer was peeling. Second: there is crack on upper part of column. Third: There is colour change, Right: effect from dampness

The eroded painting may cause by the constantly exposed to temperature fluctuations, so the paint will expand and contract according to the chances in temperature. Over time, this will result in small cracks and openings that will allow the infiltration of moisture, salt and other chemicals that will cause rust and rapid deterioration of the paint. There is also effect from dampness and concrete render as shown in picture below.

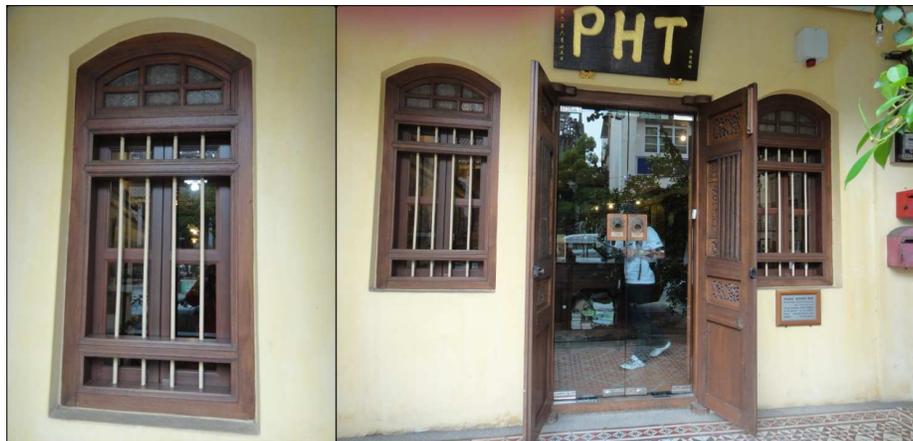
There is no defects can be detected and the windows are in satisfactory order. The doors also have no defects or timber decay presence. It is free from termite an insects attack. Figure 3 shows the windows, door and external joinery of the inspected building. It been fixed with timber frame window and timber glazed door.

**Figure 3.** From left: timber frame window. Right: Timber glazed door

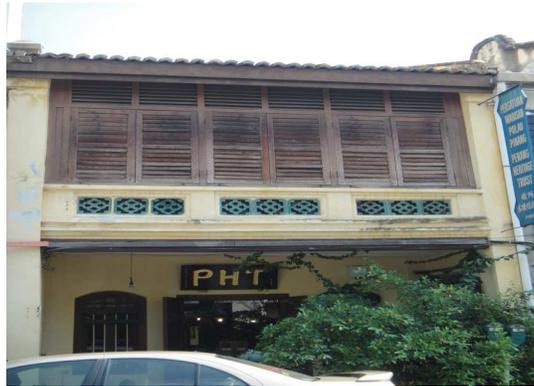
The exterior decoration has peeling paint. It may be caused by the exposure of temperature outside the building. Figure 4 shows exterior decoration of the building. Upper floor uses mostly wood and ground floor uses paint as internal finishing for decorations.

**Figure 4.** Exterior decoration and appearance

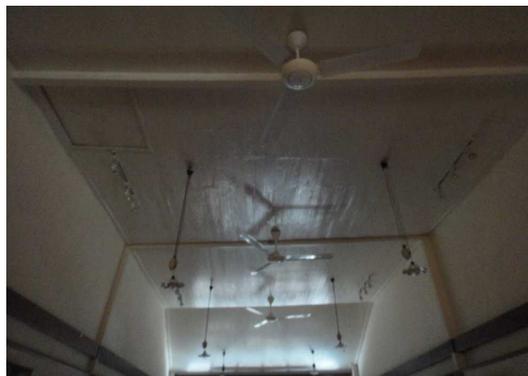
The ceilings have been inspected from within the balcony and room. No opening up has been taken. Ceilings surfaces appear to be in reasonable condition and no signs of significant damage and distortion. There is present of maintenance ceiling in first floor ceiling. Figure 5 shows the ceiling of the first floor which is free from any defects.

**Figure 5.** The ceiling of the first floor free from defects

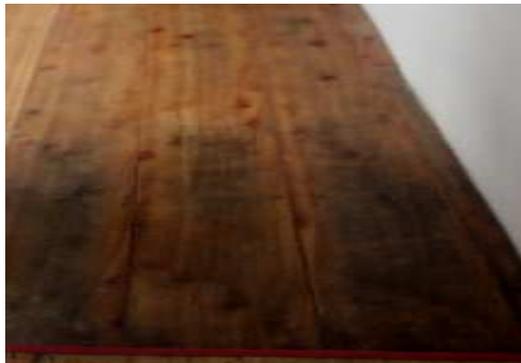
No crack, colour changing, decay and sound are produced during walking on it. But in the balcony there is colour change in timber (Figure 6) but the strength of timber is in satisfactory grade. This may be due to age of buildings and the balcony part is exposed to outside factors like sun and other elements.

**Figure 6.** Black marks on the timber surface at balcony area

All timber material use in accessible area is in satisfactory condition. No is no evidence of decay and infestation. There is only colour changing in balcony at first floor. But it is consider normal and safe considering the property age

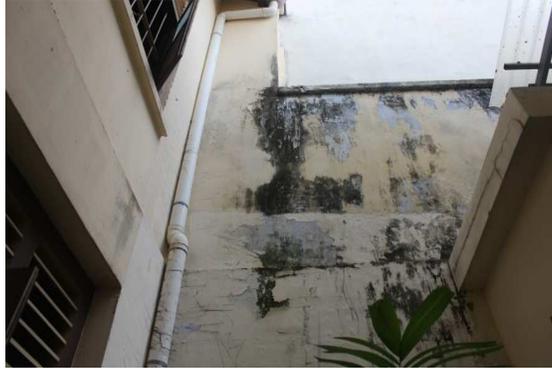
During the inspection, the instruments of electronic meter were not carried out. But from bare eyes, it could be obviously seen the evidence of penetrating damp. It occurs when rain penetrates the external fabric of the building (Figure 7).

**Figure 7.** Penetrating damp evidence
