Mădălina-Elena Mânzână, Brândușa Ghiban, Nicolae Ghiban, Ilare Bordeașu, Florin Miculescu, Mihai Marin

Different Aspects of Cavitation Damages in Some Stainless Steels

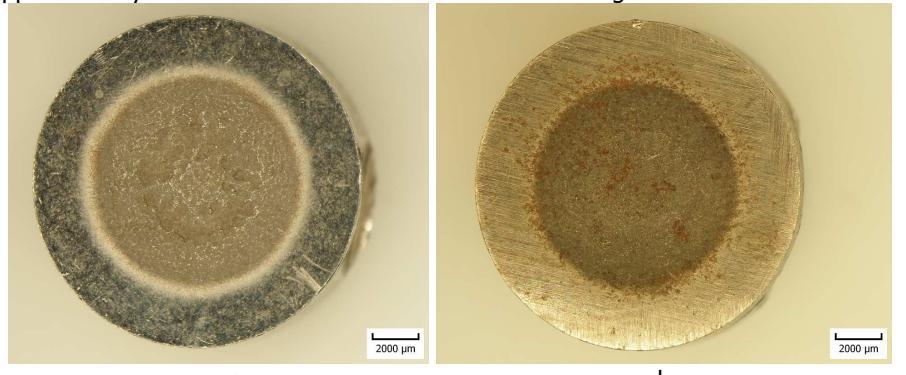
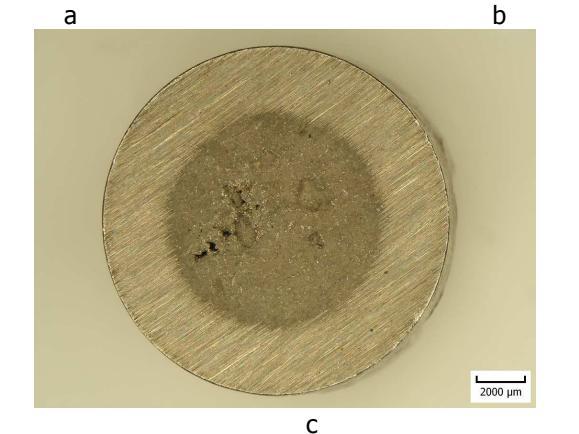
Figure 1. Stereomacroscopic aspect of stainless steel samples: a – steel A, b- steel B, c- steel C

In steel A the surface attacked by cavitation is found approximately in a concentric circle (figure 1 a) and also it can be observed huge macroscopic interconnected cavitations with radial disposal.

In figure 1b which is from steel B the cavitation attack is also found approximately in a concentric circle and the surface has general corrosion.

In the steel C from figure 1c the surface degraded through cavitation is well delimitated and it presents a huge cavitation gap in the left side of the cavitation.

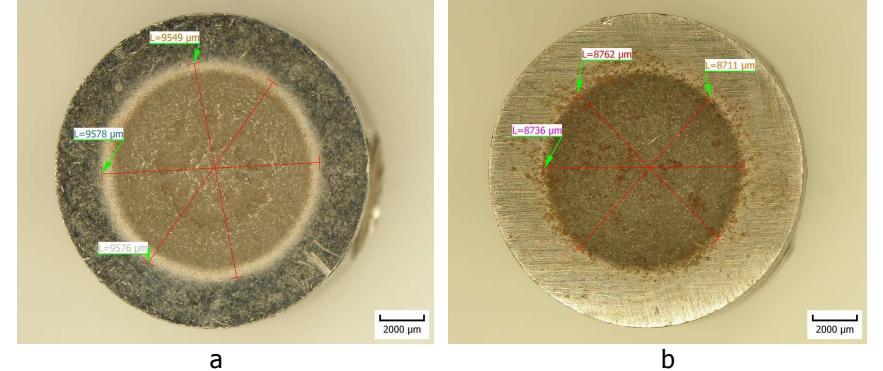
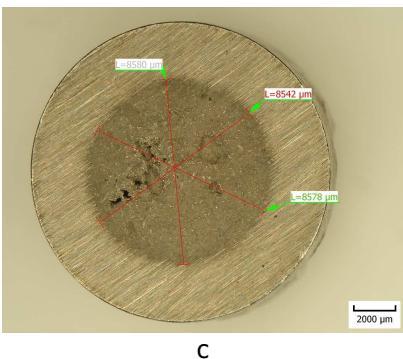
Figure 2. Stereomacrostructural aspect of stainless steel samples after measuring cavitation affected zone: a – steel A, b- steel B, c- steel C

So only 48.81 % of surface in steel A is affected by cavitation (figure 2 a), about 40.71 % of surface is affected by cavitation in steel B (figure 2 b) and, respectively about 38.60 % of surface is affected by cavitation in steel C (figure 2 c). The best cavitation behaviour is for steel C.

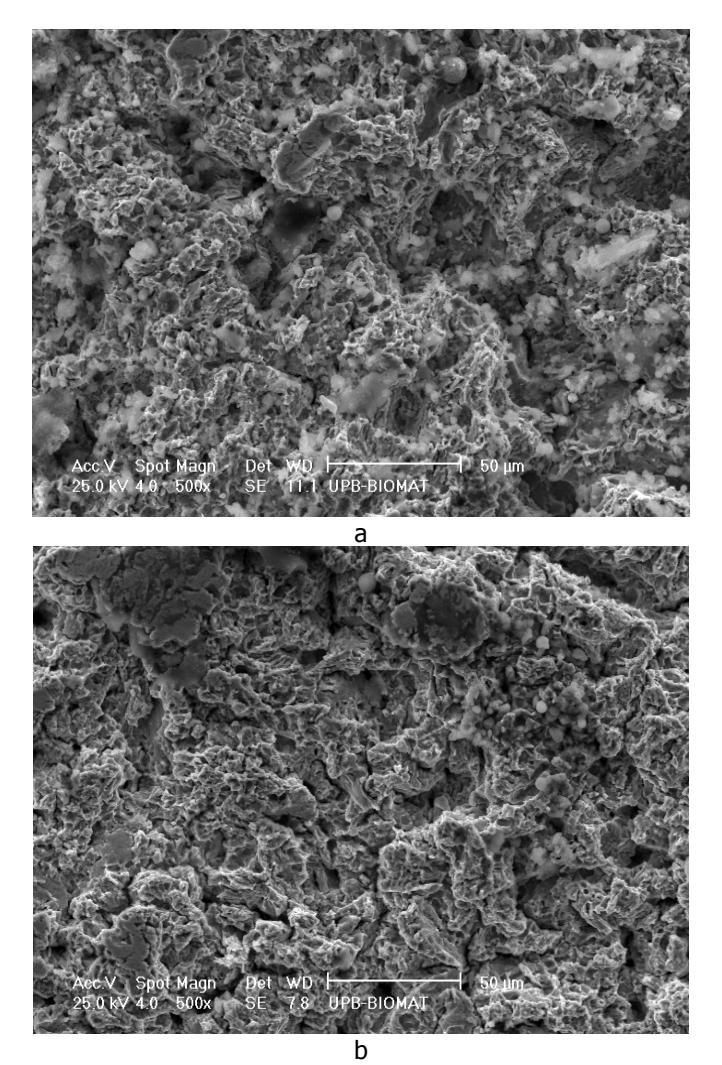
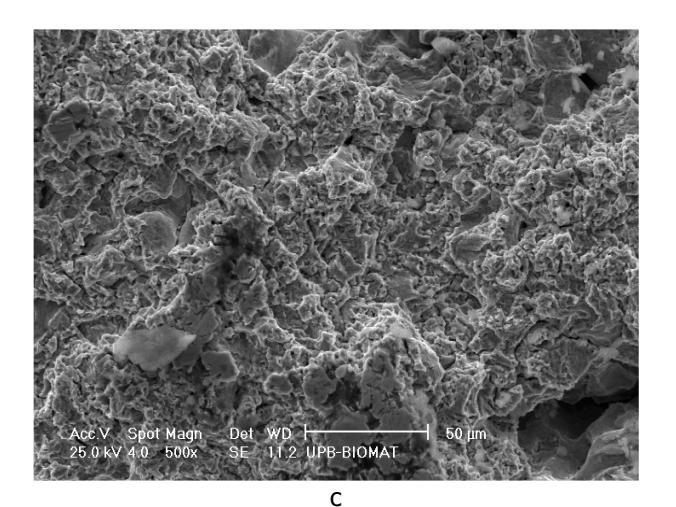
Figure 3. Structural analysis at scaning electron microscope (SEM), after 165 minutes of cavitation loading (x500): a- steel A, b- steel B, c- steel C

Figure 3 reveals the structural analysis at scaning electron microscope of the experimental stainless steel. So, at steel A there are put in evidence surfaces mixed with fine and big cavitation; surfaces with secondary intergranular cracks; fragile character breaking with propagation intergranular cracks. At steel B is presented fragile breaking with aspect intergranular; surfaces mixed with fine and big cavitation. In steel C is observed surface with very fine cavitation; aspect mixed of cavitation and cleavage planes with very fine intergranular cracks.
