Rozliani Mansor, Md Azree Othuman Mydin, Mazran Ismail, Wan Mariah Wan Harun

Categorization of General Problems and Defects in Historical Building

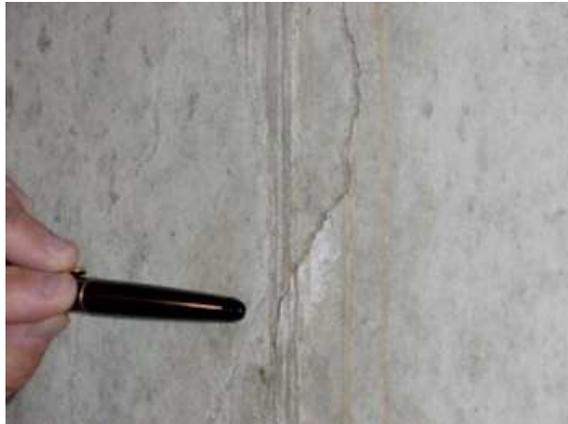
big that sometime it can occur throughout the structure thickness. Concrete easily cracks during the shrinkage because of the load applied on them. This type of cracking can occur as early as after the concrete structure was build and sometimes it takes several months to form (Figure 1).

Figure 1. Shrinkage cracks appear on wall

Concrete will shrink at first one hour it was mixed. This shrinkage process can occur interminably in a span of one month. There are two types of shrinkage cracks namely Drying Shrinkage Cracks and Plastic Shrinkage Cracks. Drying Shrinkage Cracks starts when the concrete mix started to lose the moisture and may continue for months. Usually this drying process causes fine line but this crack is not harmful to the structure. The size of this crack is less than 0.08 mm [3]. This cracking also not deep but occurs at the surface only. Plastic Shrinkage Cracks on the other hand is usually deep and its size is quite

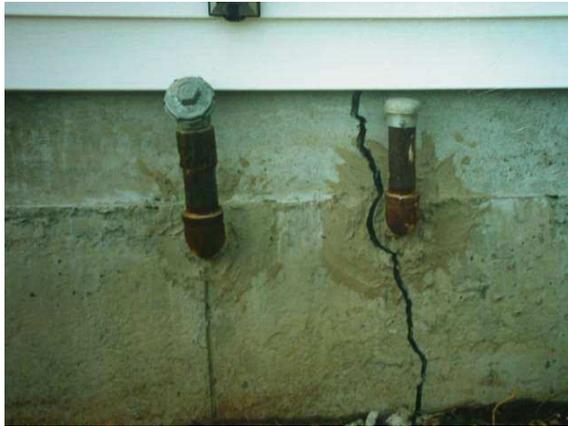
will stabilize while another half may cause fundamental concrete to crack or damage and the same effect goes to the upper building structure. The cracking defects of the building can further be divided into two types that is the first is small cracking and secondly is the active huge cracking [4]. Figure 2 shows a significant settlement crack.

Figure 2. A significant settlement crack

If the settlement happens at the same level, the defects if any are not to large extent but if the settlement is not at same level, half of the foundations

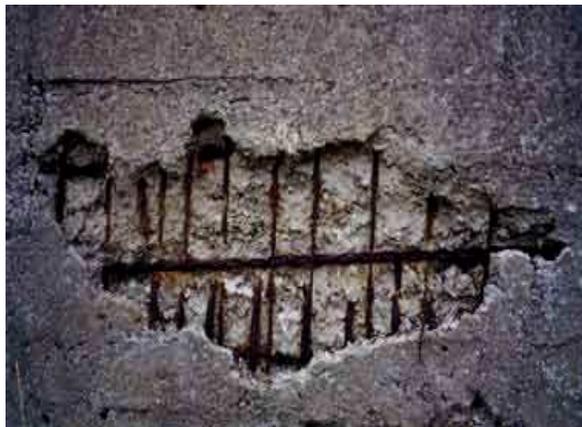
According to Philip H. Perkins [2] Spalling occurs subsequent to cracking. When cracking goes unchecked, it will become huge and the concrete on which account, becomes spalled (Figure 3). Spalling can occur due to the following:

Figure 3. Concrete spall exposing the rebar

- ii. When the steel reinforcement in the component structure is rusting, it will crack along that reinforcement. When this cracking continues, the concrete spalling follows suit.

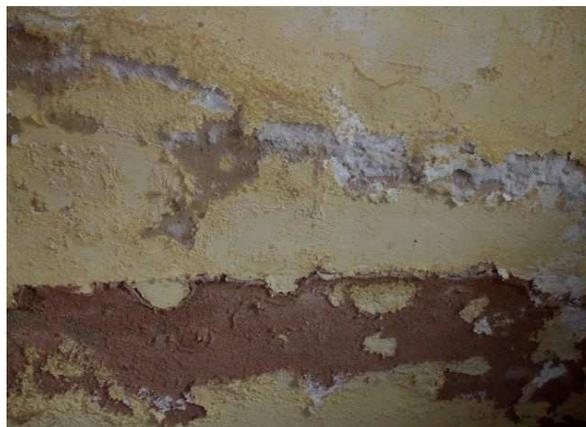
Figure 4. Salt attach to brickwork

Various types of soluble salts are known to cause damage to building masonry, including sodium chloride, carbonates, nitrates and sulphates of calcium, magnesium, potassium, sodium sulphate and magnesium chloride. According to A. Ghafar Ahmad and Haris Fadzilah Abdul Rahman [5] there are two types of salt attack that will depend on which building area the salt penetrates (Figure 4). When salt penetrates the surface and white powder is formed, this phenomenon is known as efflorescence and is harmless to the masonry (apart from creating an unsightly visual appearance).

Salt may also attack by penetrating from below the surface; this is a more serious condition as the salt will become crystallized, a phenomenon known as sub-florescence. Pressure from the growth of the crystallization process will cause building materials to crumble, resulting in serious damage to the buildings. Salt-induced weathering is due to three factors, namely geographical location, type of sandstone (building materials) and cleaning regime (maintenance of the building).

Ground water contains chlorides and nitrates, which are hygroscopic. Both soluble salts can cause visual signs of dampness and decorative spoiling on the wall when present in large amounts

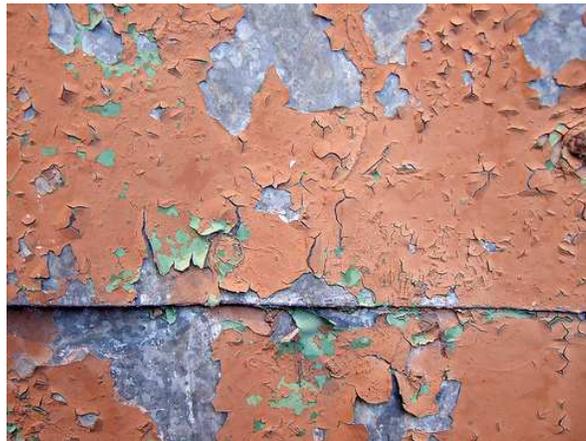
Peeling paint (Figure 5) usually occurs on building facades, mainly on plastered walls, columns and other areas which are exposed to excessive rain and dampness. Some building located near the sea may face a much greater risk once the signs of peeling paints are visible on the exterior walls [1].

Figure 5. Peeling paint from wall surface

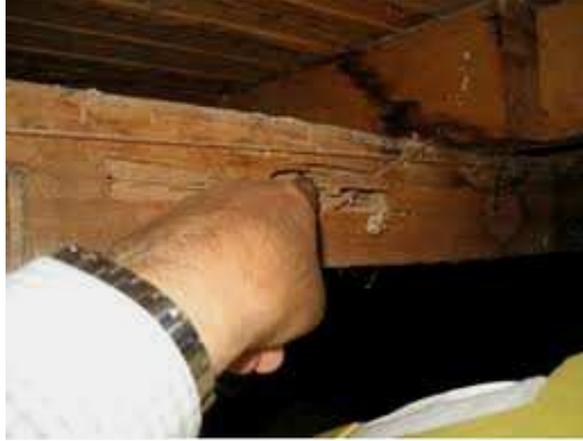
Figure 6. Extensive termite damage

Timber can deteriorate easily if left exposed to water penetration or high moisture content and loading beyond its capacity. Insect or termite infestation poses a threat to damp and digestible timber found in wall plates, the feet of rafters, bearing ends of beam and trusses, as well as in the timbers which are placed against or built into damp walling (Figure 6). It is unwise to ignore timber that is lined with insect or termite holes because it may soften the timber and form further cracks [7].

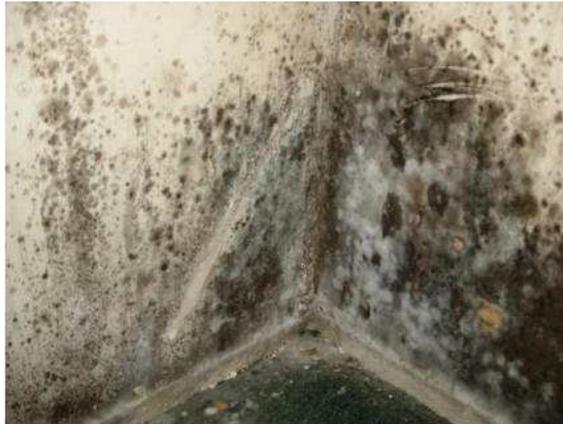
For this situation the existence of gravity, water may penetrate through capillaries or cracks between mortar joints, and bricks or blocks before building up trap moisture behind hard renders. Dampness also occurs in walls due to other factors such as leaking gutters or down pipes, defective drains, burst plumbing and condensation due to inadequate ventilation. Figure 7 shows the dampness problem occurred on interior wall surface.

Figure 7. Dampness problem on interior wall surface

Dampness can be a serious matter, particularly to building located near water sources [8]. The main cause of dampness is water entering building through different routes. Water penetration occurs commonly through walls exposed to prevailing wet wind or rain.
