Marhamah Abdul Hadi, Md Azree Othuman Mydin, Noor Faisal Abas

Investigation on Adaptive Re-use of Heritage Building in George Town, Penang

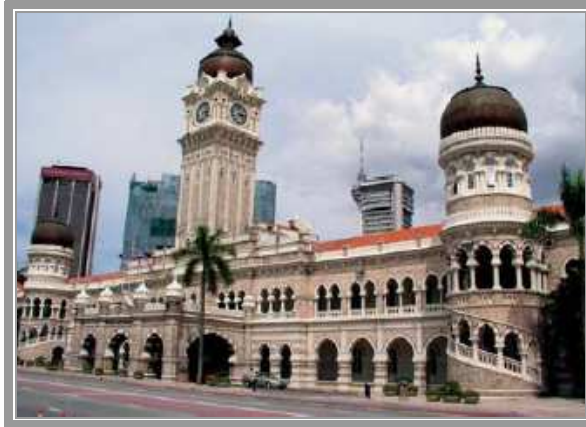
Figure 1. Bangunan Sultan Abdul Samad

In Malaysia, there are stories of success concerning on re-use of heritage buildings. In Kuala Lumpur, one of the famous adaptive re-use of historical buildings is Bangunan Sultan Abdul Samad as been shown in Figure 1. This historical building was adapted to become court which consists of Apex Court of Malaysia, the Supreme Court which subsequently renamed as the Federal Court. The Court of Appeal was also housed in this historic building.

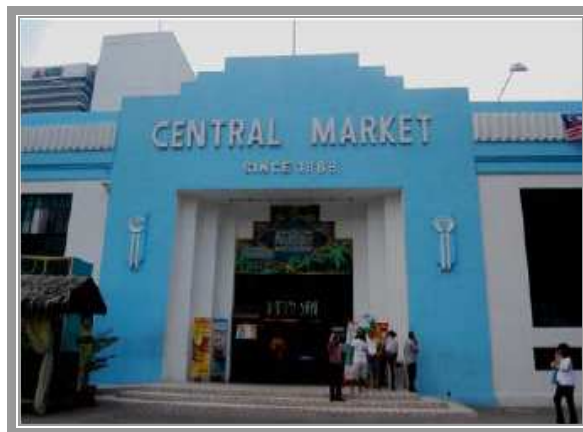
Figure 2. Central Market in Kuala Lumpur

Another good example of adaptive re-use in Kuala Lumpur is Central Market as in Figure 2. It is originally served as wet market but now it became a stall concept store that consists of several types of store like souvenir shop and even provides food court at the first floor. While in George Town, Penang, there are also

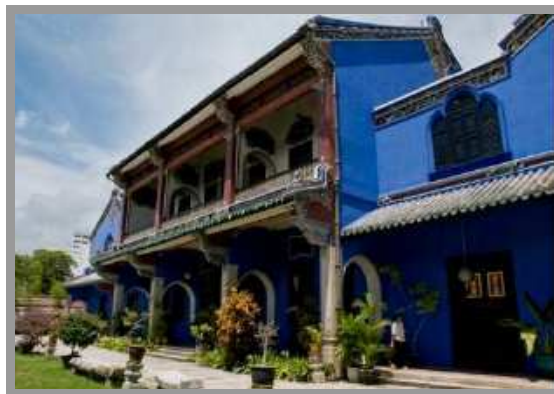
Figure 3. Cheong Fatt Tze Mansion

stories of success in re-use of heritage building and it is Cheong Fatt Tze Mansion shown in Figure 3. This mansion is very popular among tourist as their tourist destination. This building is successfully adapted to become boutique hotel. Boutique hotel is a hotel to tourist to stay but the heritage characteristic of the building is still being preserved. Besides boutique hotel, this mansion also used for newly married couple to take a picture here. This is one of the reasons Cheong Fatt Tze Mansion is popular among tourist as well as locals. It gradually became one of the main attractions in Penang.

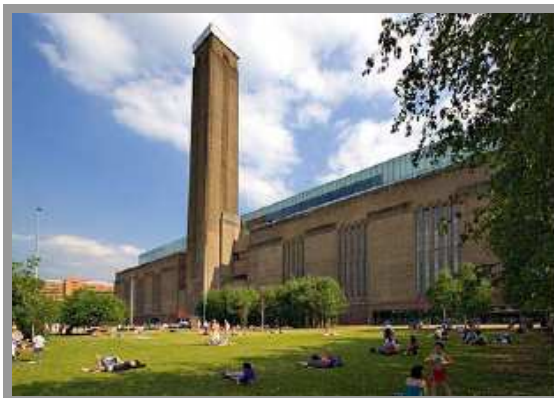
Figure 4. Tate Modern Gallery

Adaptive re-use not only related to heritage buildings, it also related with other kind of building such as commercial. One of the famous example adaptive re-use of commercial buildings to gallery is the Gallery of Modern Arts for the Tate museum in London, United Kingdom. The museum (Figure 4) was once a power station. It was constructed in 1947. The power plant shutdown in 1981 and this was transformed in 2001. It is situated on the south bank of the river Thames.

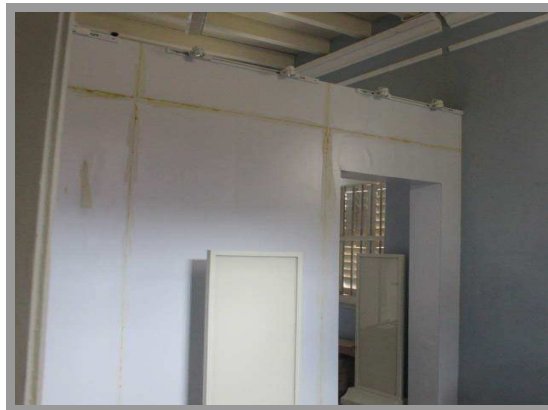
Rumah Teh Bunga has a unique structure of house. Adapting buildings to meet new uses and modern standards involves making physical changes to the existing building [5]. Based on the research done, structurally, this mansion did not undergo major changes in structures. The only structure that has been removed in order to do a conservation work on this mansion is the partition walls. The partition walls are used by previous owners to separate the bedrooms for his children. The partition walls used are made from plywood. It is also found that although the homeowner's changes, but the whole fabric of the house and characters still remain unaffected. The changes in terms of structure can also be seen from this mansion in turning it to become gallery. It is the addition of partition wall at the ground floor at the two bedrooms that are adapted to become exhibition area (See Figure 5).

Figure 5. Addition of partition wall at the ground floor

Based on the interview done, the partition wall is made from timber structure and it is covered with a material called "Papan Lapis Cantik" (Glossy Plywood). This addition of partition walls is used as part of the requirement of becoming a gallery. The partition wall build is permanent. This partition wall also

can be found on the next bedroom that facing each other. Both of these rooms are adapted to become exhibition area for the gallery. This partition wall also do not carry load for the structure of both rooms.

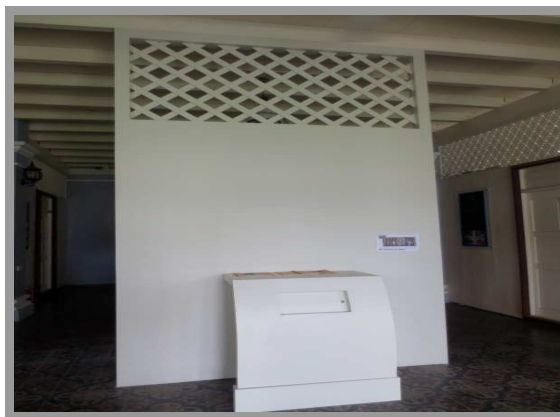
Apart from partition wall, another addition of structure found in this mansion is also the timber structure covered with Papan Lapis Cantik material at the lobby. This structure is used for decoration purposes in the lobby. The structure used for this lobby is same type used in the exhibition area. This structure also does not carry any load for this mansion (see Figure 6).

Figure 6. Timber structure covered with "Papan Lapis Cantik" material

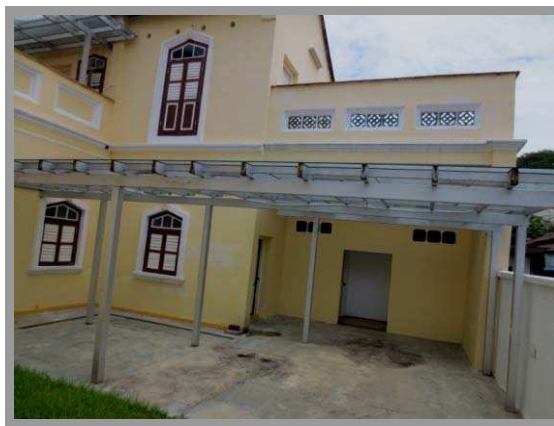
Figure 7. Sun Shelters at the external area

Besides that, there is also an addition of sun shelters at the external area of this mansion. Previously, this sun shelter does not exist and it is built after this mansion is properly conserved. The structure like beam and column of the sun shelter is made from steel. The function of this sun shelter to provide a shelter from the sun for the people and the visitors that came to this gallery. This sun

shelter is also connected to the VIP toilet. Based on the interview done, this shelter also acts as a parking for VIP. See Figure 7 for sun shelters at the external area. On the first floor of this mansion, it is also provided with the same type of sun shelters. It is used to cover the open space at the porch. See Figure 8 for the sun shelters at the first floor area.

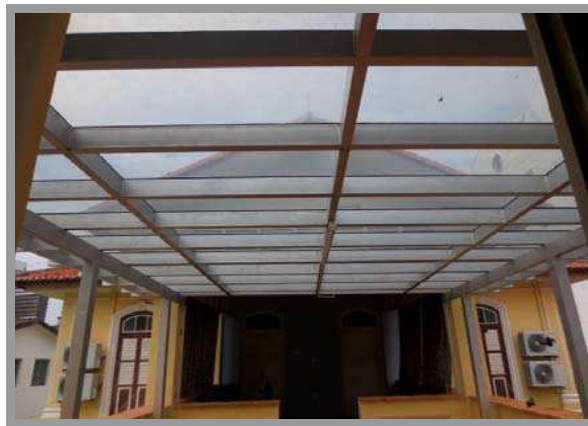
Figure 8. Sun shelters at the first floor area

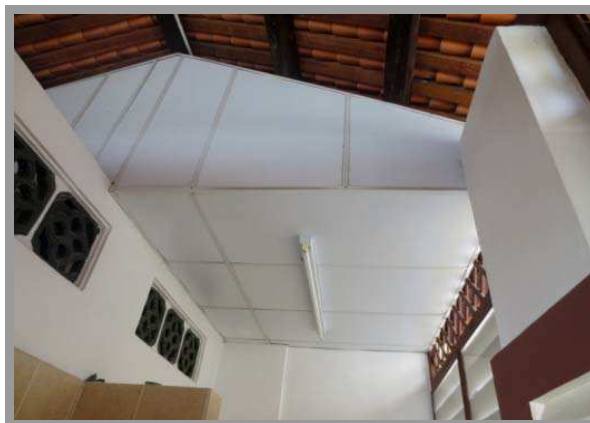
Besides sun shelters, they have also build a suspended ceiling at the toilet (See Figure 9). The toilet previously functioned as a horse-drawn carriage room. Then, they decided to build a toilet as a current requirement for the future usage of this mansion which is a gallery. They build two toilets for this gallery, a toilet for visitor while another toilet for the VIPs. Currently, these toilets are only used by the person in charge that takes care of this building which is, the guard man. Figure 9 shows the suspended ceiling builds in the toilet. Previously, the ceiling does not exist.

Figure 9. Suspended ceiling in the toilet

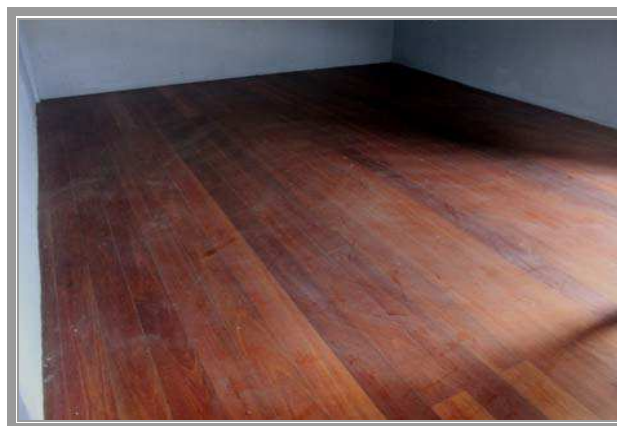
Figure 14. Meranti Merah used for timber flooring

Timber is a common material that is used in heritage buildings. During the conservation phase, they decided to change the timber flooring completely. The reason behind this decision is the old timber flooring is too brittle and was not safe to be used. Firstly, they found the type of timber flooring this mansion used. However, if they do not found any type of woods that is similar, they would have to find the type of wood which have the same grade or quality as previous or original one. Therefore, the type of timber used during the conservation phase is "kayu meranti merah" (See Figure 14).

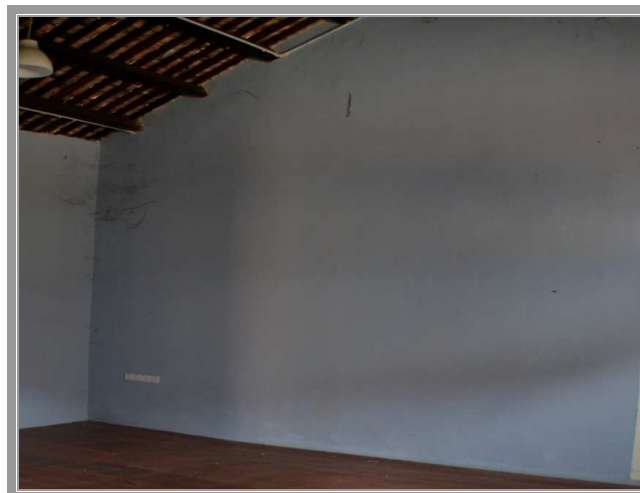
Figure 15. The interior wall paint for Rumah Teh Bunga

After finished replacing the new plaster, the wall needs to be painted. The paint used to paint this wall is a special paint. The special paint is usually used only for heritage buildings is "Cat Air" and the brand that usually used is Lota Paint. This special paint is the only paint that is suitable with the plastering material, which is lime. Besides that, this special paint is used because it can last longer on the heritage buildings. They also paint the wall according to the original color of the wall which is blue. Figure 15 shows the interior wall paint for Rumah Teh Bunga while Figure 16 shows the exterior wall paint for Rumah Teh Bunga.

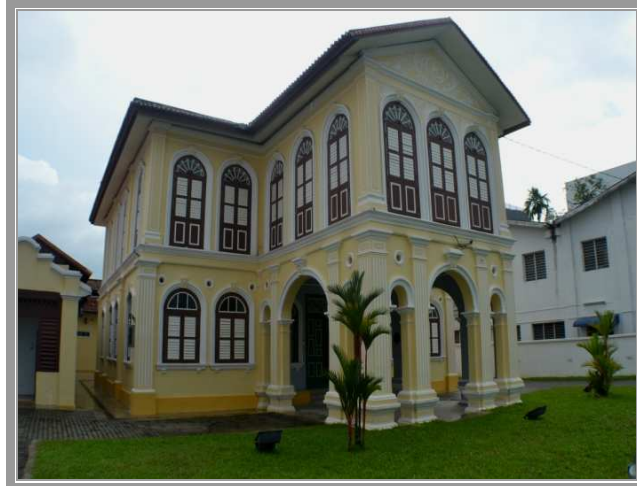
Figure 16. The exterior wall paint for Rumah Teh Bunga

They also paint the wall with the original colour of the house. External wall was painted with the chrysanthemum flower colour. Meanwhile the internal paint is a paint that is in a blue shade colour. They identified that, the blue colour was the original colour for the interior wall. Regarding to the colour of the paint for external wall, they did some research near the surrounding neighbouring area about the colour of the mansion.

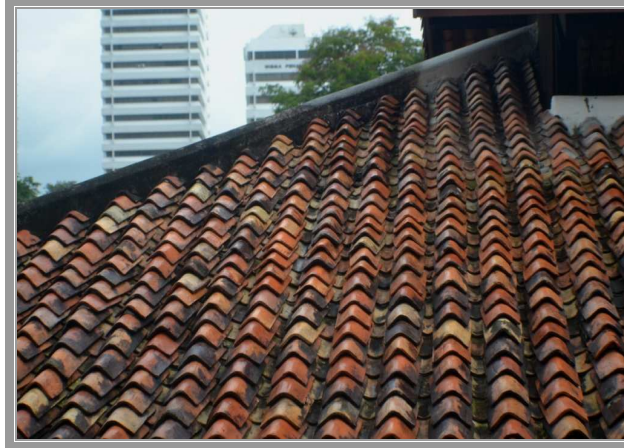
Apart from terracotta tiles, V tiles for roof covering had also undergone partially changes. Some of the good condition of V tiles is still used in this mansion. The original V tiles are placed at the rear side of this mansion. While the new replaced V tiles are used at the front sides of this mansion. This is to show the respect for this heritage building. Figure 17 shows the original V tiles used for roof covering and Figure 18 illustrate the new replaced V tiles.

Figure 17. Original V tiles for roof covering

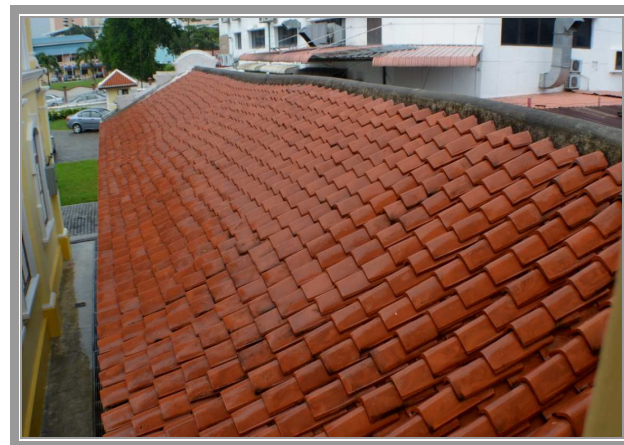
Figure 18. Replaced V tiles for roof covering

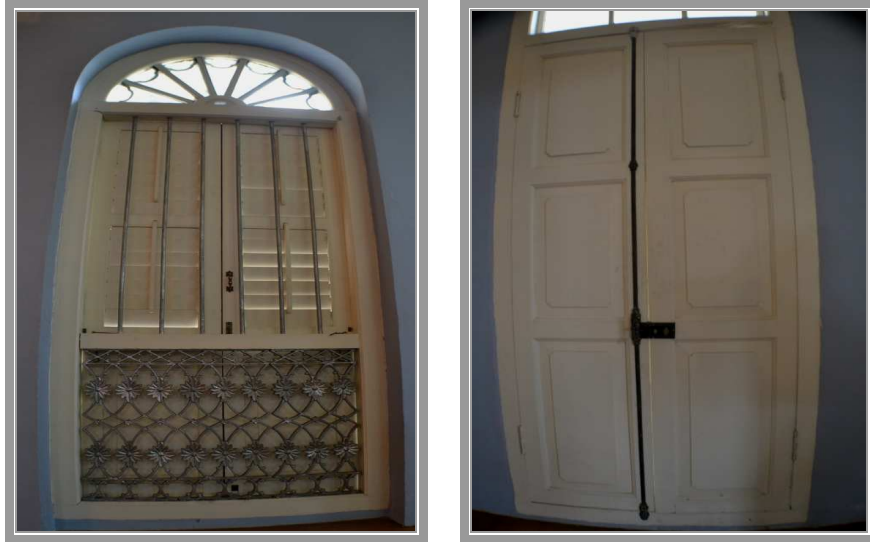
The component of door and window that are made from wood component are then being replaced with the same design and material of wood. They managed to find craftsmen that can produce the same design of door and window. See Figures 19 for door and window component.

Figure 19. Window and door component respectively

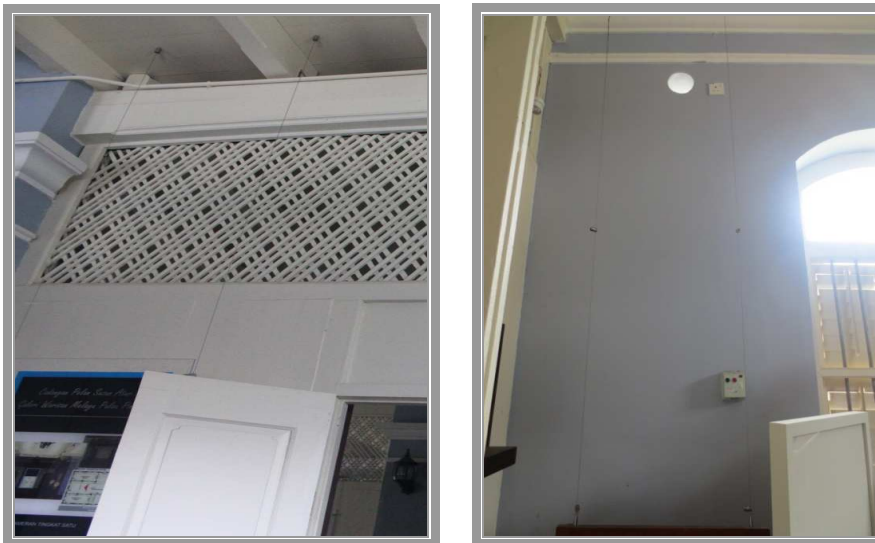
Now, we will be looking the type of material used for the window glasses. The windows used before have intricate design on them. However, new window glasses are replaced without any design on it. The decoration materials used for the gallery for example panel graphic and information board which often require attaching or affixing it on the wall. However, in this case, they would like to minimize the intervention made to the wall. One of the conservation guidelines that need to be followed is that there is no renovation work that will cover the wall to the maximum. It is because the wall of this mansion encounters high rate of salt problem. As a precaution step, the technique of exhibition focuses more on to a suspended approach so that it will not have a contact with the wall. See Figures 20 for the suspended approaches of panel graphic used in this gallery.

Figure 20. Suspended approaches for panel graphic

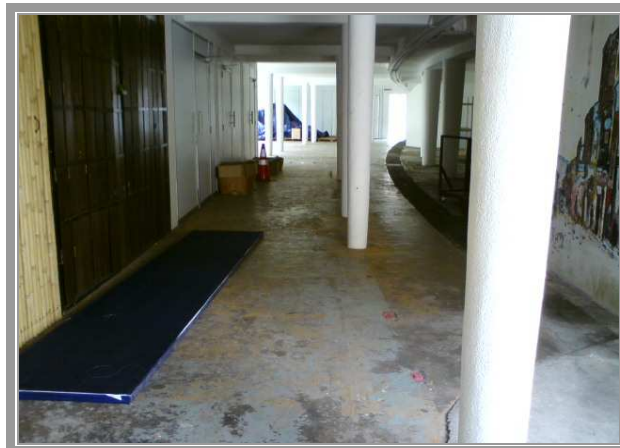
In adapting it to become a tourist attraction, they also build other structures like amphitheater and a structure special for toilet, souvenir shop and management office. This fort also previously consists of other structures that were originally built in it. The original structures found in this fort are church or chapel, cell room, gunpowder magazine, harbor light and flagstaff, and store. The actual interesting feature in this fort is the cannon itself. The cannon found on this site were the historical evidence on how this building acts as administrative building in previous years. In this structure, we can observe that there are many columns built as showed in Figure 21 that functions as a support to the structure.

Figure 21. The columns that react as support structure

There are more or less 30 columns found in this structure. This structure was built to fulfill the current requirement for this fort that to become a tourist attraction. For example, the toilet built is to provide a facility to the visitor that came here. Besides that, adaptive re-use this fort, another addition of structure found in this fort is a small cottage that is made from timber frame. Based on the observation, one small cottage is found and its function is to connect another entrance of this fort. Without this small cottage, it is impossible to cross the gap

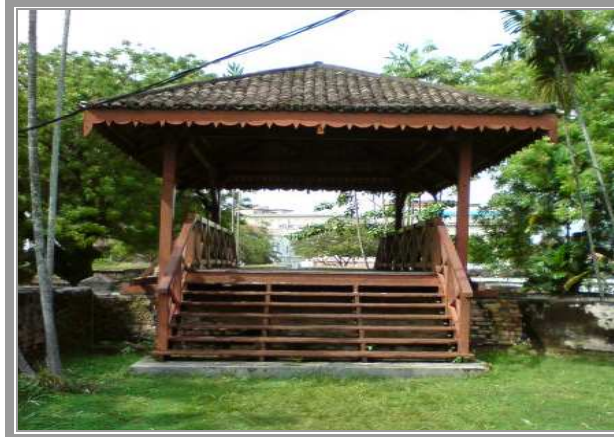
between the entrances. However, this entrance is closed and not used for the visitor. See Figure 22 for the small cottage image.

Figure 22. The small cottage found in Fort Cornwallis

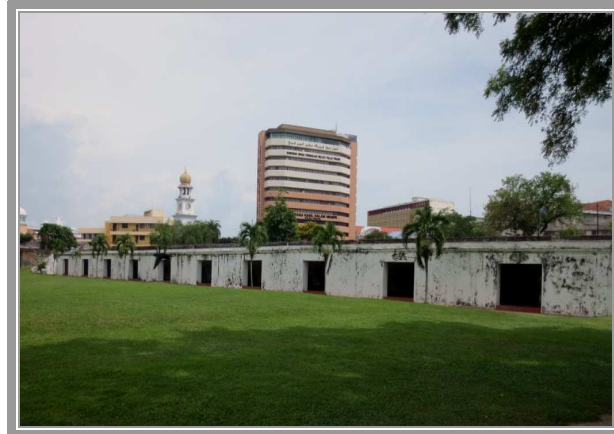
Fort Cornwallis is a very spacious area and it is an open space. Fort Cornwallis is regarded as a site rather than a building. Plus, part of the open space is regarded as archeology site. Even though the construction of amphitheater took some of the space at this fort, the space left is still considered as large. In terms of space of existing structure, the only empty space in the cell room was adapted to become a gallery. There are nine cell rooms that were used as a gallery. See Figure 23 showing the cell rooms.

Figure 23. The cell rooms

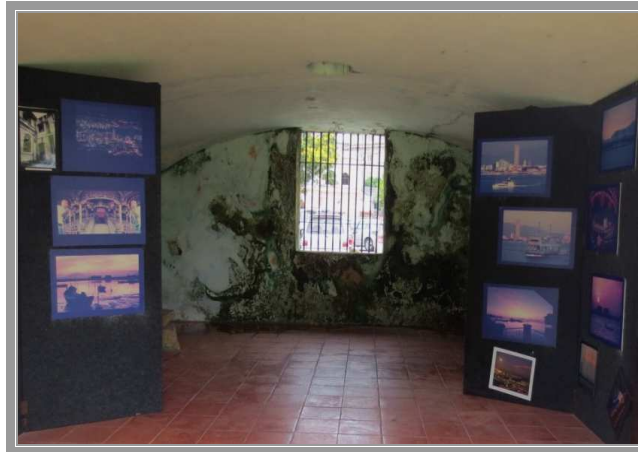
based on the observation, the space of this cell room mostly is not in a pleasant and satisfying situation. Most of the cell room experiences serious dampness problem. If any visitors that comes in, they will not feel comfortable with the poor condition of the cell room.

Figure 24. Dampness problem occurred in one of the cell rooms

Through observation also, this space is not a popular space among visitors that came to this fort. Based on the interview done, the condition of this cell room is purposely left like that, because it is accordance with the age of this structure. See Figure 24 shows the one example of serious dampness problems that occurs in one of the cell rooms.

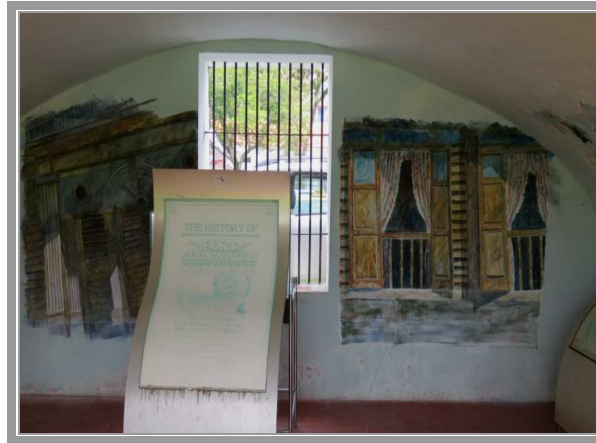
Other than artifacts display, during the inspection, a painting also found on the wall of the cell rooms. The paintings seem new and quite fresh. The function of the painting is unknown; however, it seems to enliven this dull and boring cell room. Some of the paintings done on the wall were related to past years of time in

Malaysia and some are just general painting. It is found that the paintings are done on the wall at most of the cell rooms. See Figure 25 shows the painting done. Other decorations that can be found in the fort are like sitting area, Francis Light statue, and a photo shooting board.

Figure 25. The painting done on the wall of the cell room

Followed by the painting found on the wall of cell room in the Fort Cornwallis, it could be considered as offence to heritage building. Under section 112 in matter (1) (b) stated that “no person shall, without the approval in writing of the Commissioner demolish, disturb, obstruct, modify, mark, pull down or remove any monument in heritage site”.

Since no information whether the painting is done with or without approval of Commissioner, the status of the offences is still unknown. Based on the interview conducted with MPPP officer, the painting done is not considered as an offence as long as there are no structural changes to the building. On the other hand, Prof A. Ghafar, said if the painting is new which means that previously the painting is not exist, then it can be regarded as an offence because it can damage the values of the heritage buildings.
